Corrosion of Carbon Steel in Presence of Mixed Deposits Under Stagnant Seawater Conditions on Block 2/05

Carbon Steel, Water injection pipeline, Channeling corrosion, Under-deposit corrosion, Microbiological corrosion.

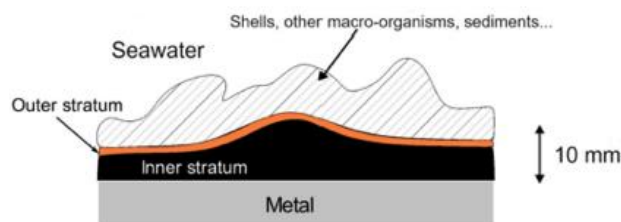
The corrosion product layer can be several millimetres thick, reaching locally a thickness of 1 cm or more. Under the biofouling layer that may incorporate mineral compounds (sand, clay, fragments of shells) and macro-organisms, an orange-brown corrosion product layer is generally seen. This is the outer stratum, mainly composed of Fe(III)-oxyhydroxides (FeOOH). Lying underneath is found the inner stratum, characterized by a black color, that is in contact with the steel surface.

Figure 5. Schematic representation (cross-section) of the layer covering a carbon steel coupon after 6-11 years of permanent immersion in natural seawater

After several years in natural seawater, a corrosion product layer itself covered by bio fouling covers the surface of carbon steel structures permanently immersed in natural seawater. Figure 1 displays the main features of the layers formed on carbon steel coupons after 6 to 11 years of immersion.

This inner stratum is mainly composed of Fe(II)-based corrosion products, mixed with magnetite Fe₃O₄.

The Fe(II)-based compounds are reactive towards oxygen and the Fe(III)-oxy hydroxides that constitute the orange brown outer layer are the end products of their oxidation by dissolved O₂. After 6–11 years in natural seawater, the inner black stratum is much thicker than the orange-brown outer stratum. This demonstrates that the steel surface and the main part of the corrosion product layer are no more reached by dissolved oxygen, i.e., that anoxic conditions are met. This explains why anaerobe microorganisms develop systematically inside the corrosion product layers and influence necessarily the corrosion process, as perfectly illustrated by the phenomenological model proposed by Melchers et al. [17,22]. Dissolved oxygen cannot reach the inner part of the corrosion product layer because the aerobic microorganisms that colonize the biofouling layer and the orange-brown outer stratum consume it. The little oxygen that could possibly reach the dark inner stratum would then react with the Fe(II)-based corrosion products to form FeOOH phases and/or magnetite.

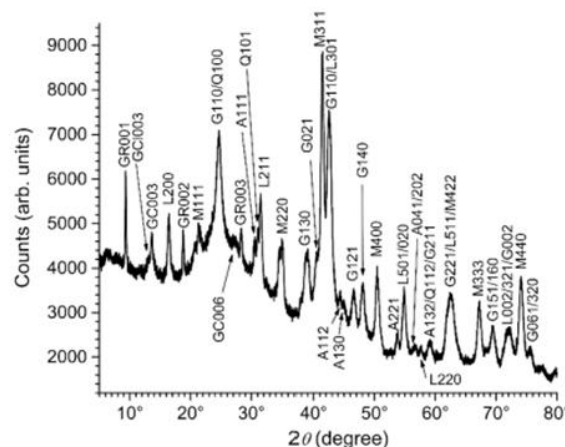
Figure 7 shows the XRD pattern of the corrosion product layer that covered a carbon steel coupon immersed 6 months in natural seawater (Les Minimes marina exposure site, La Rochelle, Atlantic Ocean). The main crystalline solid phases that constitute such corrosion product layers are all detected here. Two Fe(III)-oxyhydroxides, namely goethite -FeOOH and lepidocrocite -FeOOH, are identified.

Figure 7. XRD analysis of the corrosion product layer covering a carbon steel coupon after 6 months in natural seawater (Internet: www.elsevier.com)

They constitute the orange-brown outer stratum. Magnetite, the Fe(II,III) mixed-valence oxide Fe₃O₄, is identified too. It is present in the inner dark layer. Magnetite can form in anoxic conditions as shown by thermodynamic data e.g., [49,50]. The overall reaction involves the oxidation of three Fe(0) atoms to one Fe(II) cation and two Fe(III) cations, and the reduction of four water molecules to hydrogen. It can be written as.

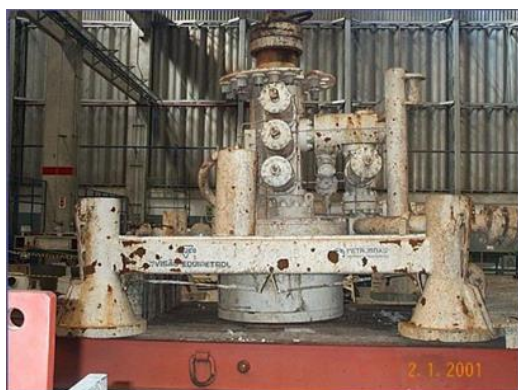
Figure 8. Christmas Tree - Subsea Equipment (After 20 years submerge) (Internet: www.cortecvci.com/cortec-corrosion-solutions-available-around-the-globe)

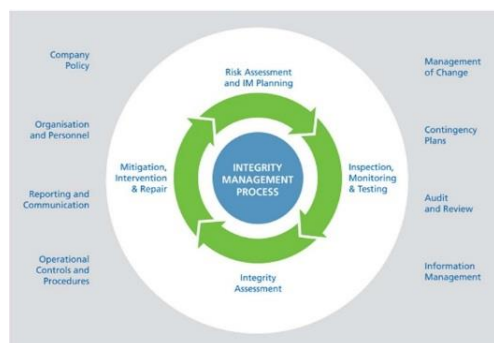
Figure 10. The Integrity Management (IM System)

Established during the concept, design and construction phases. Transferred from the development phase to the operations phase. This interface involves transfer of vital data and information about the system.
